Mobile Pentium® II Processor Specification Update

Release Date: October 1998

Order Number: 243887-003

The Mobile Pentium® II processor or the Intel® Pentium II Processor Mobile Module may contain design defects or errors known as errata which may cause the product to deviate from published specifications. Current characterized errata are documented in this Specification Update.

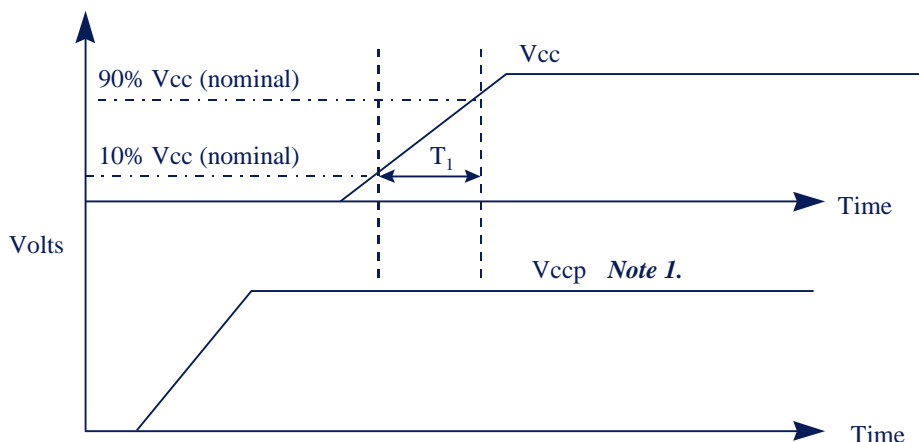
Figure 1. V_{CC}/V_{CCP} Timing Requirements (Mobile)

PROBLEM: The processor uses the PWRGOOD signal to ensure that no voltage sequencing issues arise; no pin assertions should cause the processor to change its behavior until this signal is asserted, when all power supplies and clocks to the processor are valid and stable. However, if V_{CC} ramps up before V_{CCP} , it will cause the processor to enter an invalid state.

IMPLICATION: If this erratum occurs, the system may boot normally however, the L2 cache may not be initialized.

WORKAROUND: For Mobile Pentium II processors, ensure that V_{CC} ramps after or with the L2 cache IO voltage (V_{CCP}). If V_{CCP} ramps after the V_{CC} , a delay circuit can be placed on the core V_{CC} to ensure that V_{CC} ramps at the same time or after V_{CCP} as shown below in Figure 1.

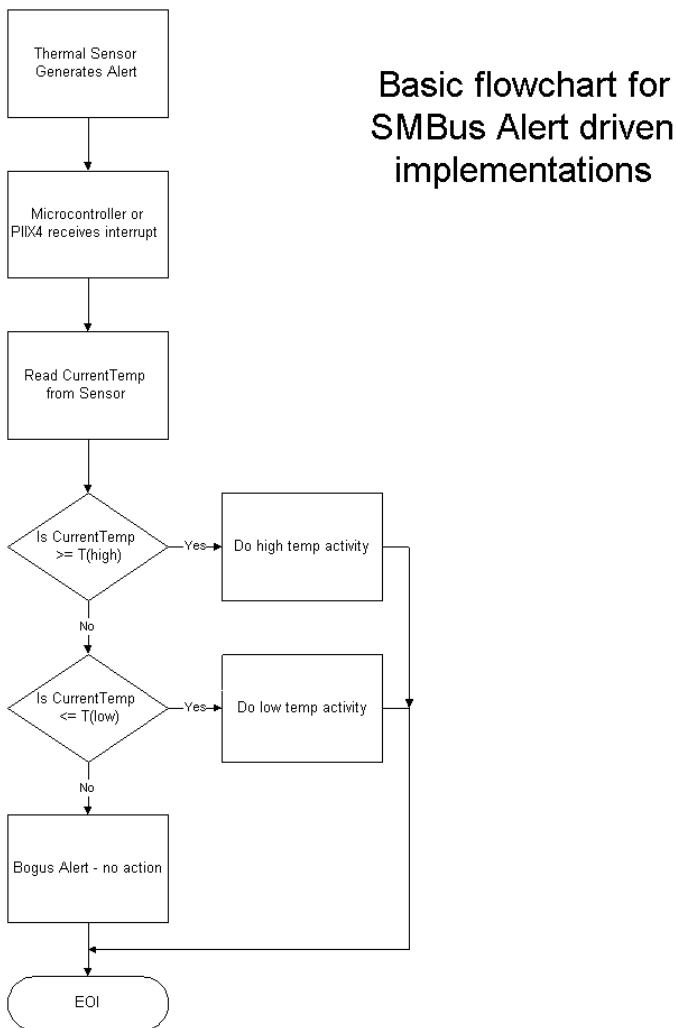
Figure 2. Workaround Flowchart: SMBALERT#-Driven System

Under the conditions described below, the thermal sensor incorrectly generates the SMBALERT# interrupt. *All* of the following conditions must be met to trigger a false interrupt:

1. Before servicing an interrupt from the thermal sensor, read and compare the processor thermal reading with the threshold limits (T_{HIGH} or T_{LOW}). Figures 2 and 3 provide basic flowcharts for the implementation of this workaround in an interrupt driven system.
2. If the firmware implemented polls the Status Register only, then before taking any action, re-read the temperature register and do a comparison with the alarm threshold limits (T_{HIGH} or T_{LOW}) to determine if the value is actually still within the temperature window.
3. Use a temperature polling scheme to monitor the processor temperature.

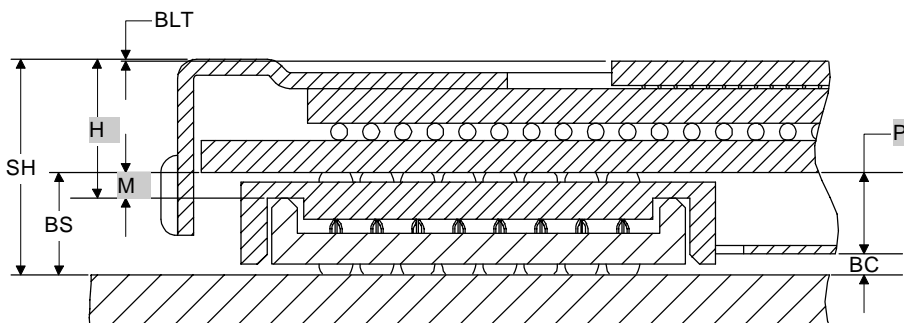
Figure 5.6. Cross Sectional View With Vertical Dimensions

B12. Misabeled Vertical Dimension Parameters

Figure 5.6 in the *Mobile Pentium® II Processor at 233 MHz, 266 MHz, and 300 MHz* datasheet should be replaced by the following figure:
